Inspection Report

Prepared For:
**Rich Harrison, Lighthouse
Community Public Schools**

Report Number:
T0107

**444 Hegenberger Rd
Oakland, CA**

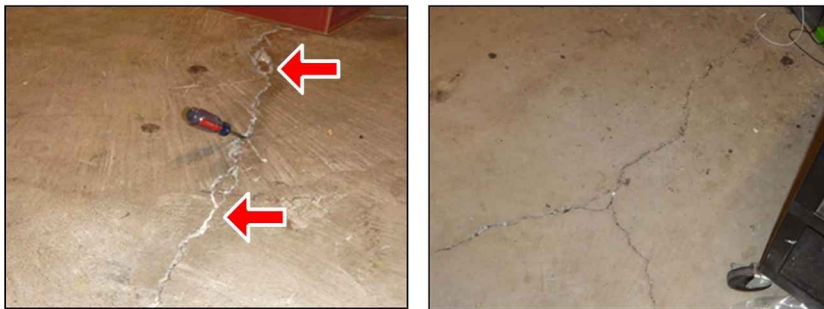
Small and/or moderate slab foundation cracks were observed in room S134, indicating past settlement, but we observed no related conditions suggesting the need for immediate repair. These cracks should be monitored, and if ongoing movement is observed, further evaluation by a structural engineer is recommended.

Cracking in slab

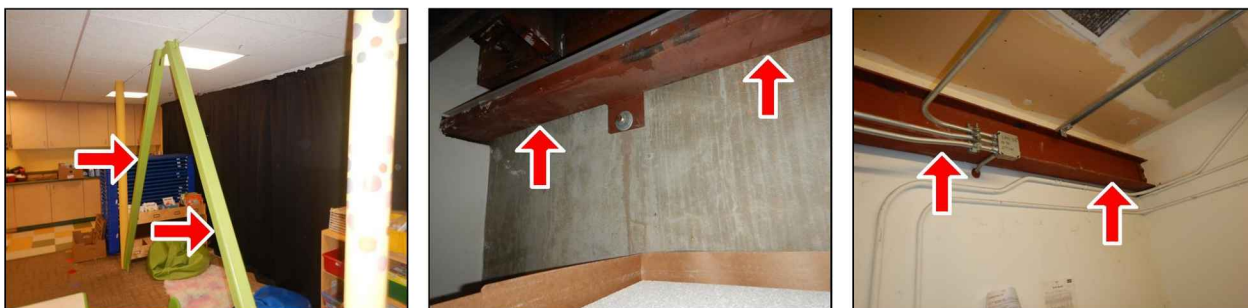
Significant seismic upgrades were installed on this building, however no comment is made regarding the design or engineering involved. For more information about the adequacy of these upgrades, a licensed structural engineer should be retained for an analysis of work performed and any available plans or designs.

Seismic strengthening

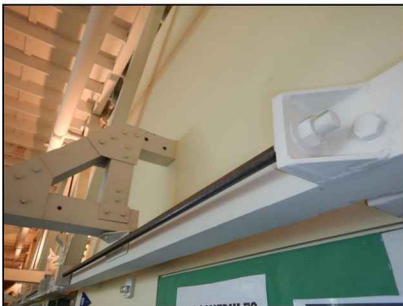
The visible roof trusses were generally in acceptable condition. Modifications have been made to the roof trusses. We recommend a history of the modifications be obtained. This should include, if possible, the date repairs were made, the contractor's name, a description of changes made, and any available plans and permits. A determination as to the adequacy of these repairs is beyond the scope of this inspection.

Truss modification

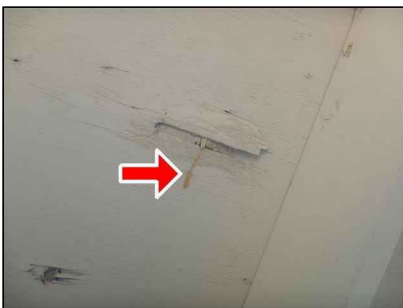
The roof sheathing was stained and damaged in a few areas. We recommend review and repairs as necessary by a licensed contractor to restore proper support.

Stain in S222

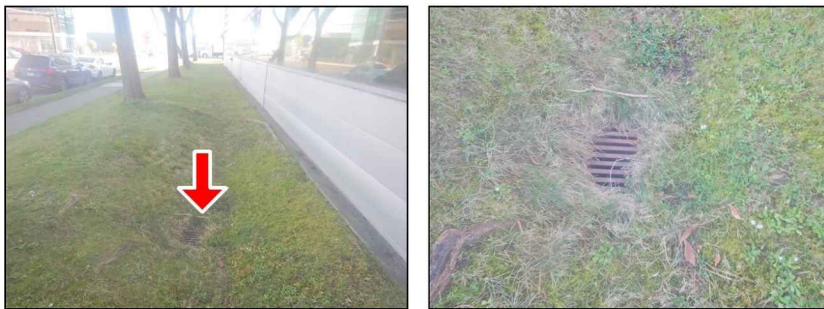
A partial drainage system was installed on this site. We recommend observing drainage performance for a full cycle of seasons or until deficiencies emerge. If negative conditions arise, then appropriate modifications should be made.

Perimeter surface drainage

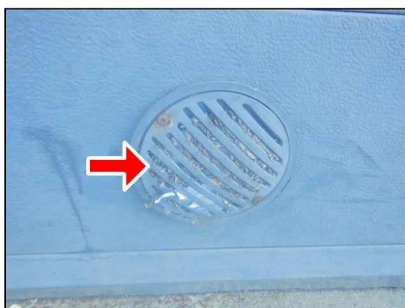
The roof drainage was not properly extended away from the building, and several of the roof drainage outlets (lower exterior walls) were clogged with debris which can cause leakage and damage to the building. We recommend the discharges from all downspouts be routed sufficiently away from the structure (usually at least 5 to 10 feet).

Clogged roof drainage outlet

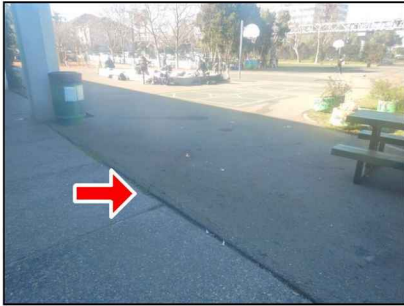
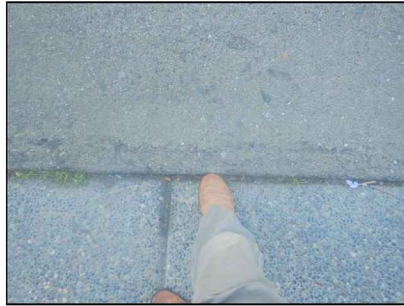
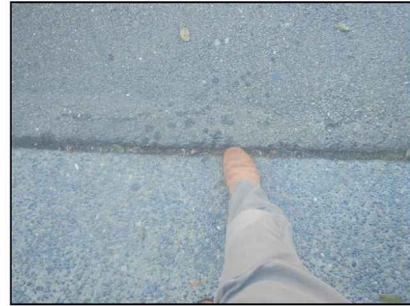
Trip hazards were observed in some of the walkways, especially at the transition from concrete to the asphalt playground. We recommend a thorough review and repairs as necessary to eliminate trip hazards and reduce the potential for personal injury.

Trip hazards at playground

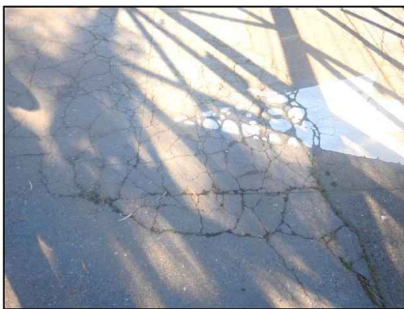
! The asphalt pavement was cracked and uneven, especially at the left entrance (Hegenberger Loop). We recommend consultation with a licensed asphalt contractor for advice, repair options, and cost estimates.

Cracked, deteriorated asphalt

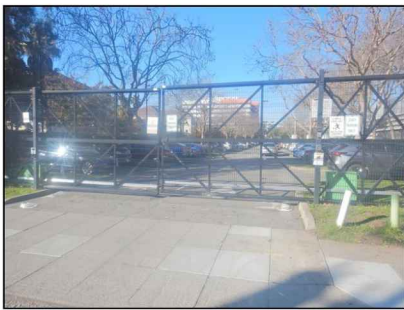
Automatic driveway gates were installed, but they were not tested and we did not confirm the proper operation of the safety controls. Safety controls can prevent in damage or injury and we recommend further evaluation by a licensed gate specialist.

Automatic gates not tested

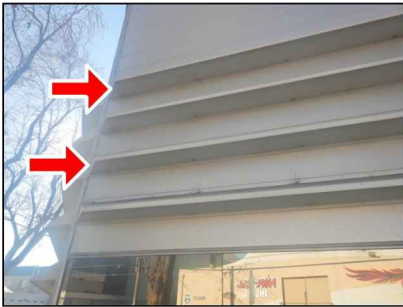
Corrosion was observed on the undersides of the architectural siding trim overhangs. The rusted siding should be cleaned, primed and painted to help prevent further deterioration. Eventual replacement will be required if there is continued deterioration. We recommend review and repairs as necessary by a licensed contractor.

Overhangs

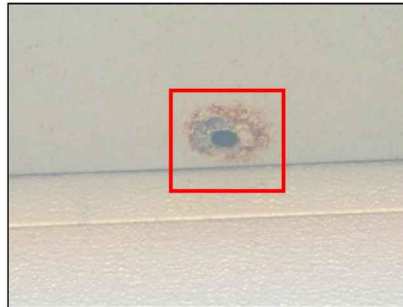
Rust

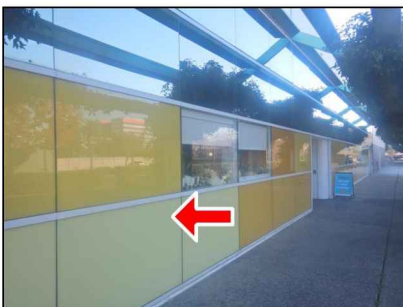
What appeared to be glass panel siding was installed along the right side of the building, adjacent to the playground area. We could not confirm that the (apparent) glass was a safety type. An etched emblem in the corner of each pane will usually identify safety glass, but no such emblem was found. We recommend evaluation of the panels to determine if it was safety glass (or safety film) by a licensed contractor to prevent injury from broken glass shards.

Apparent glass panels

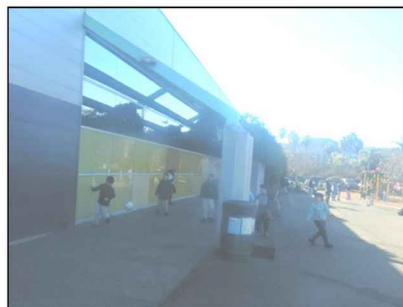
Siding adjacent to playground

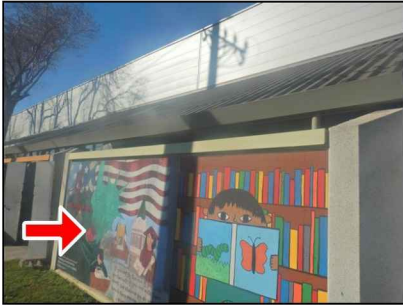
While examination of the fences were beyond the scope of this inspection, we noted that the plywood mural fences or wall panels at the left side were damaged. We recommend repairs or replacement as necessary to prevent further deterioration.

Plywood mural walls

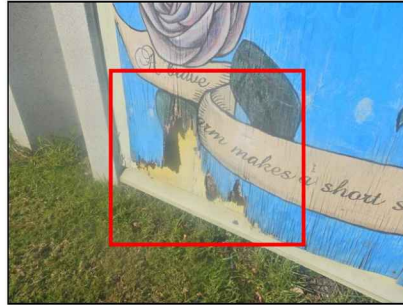
Damaged plywood

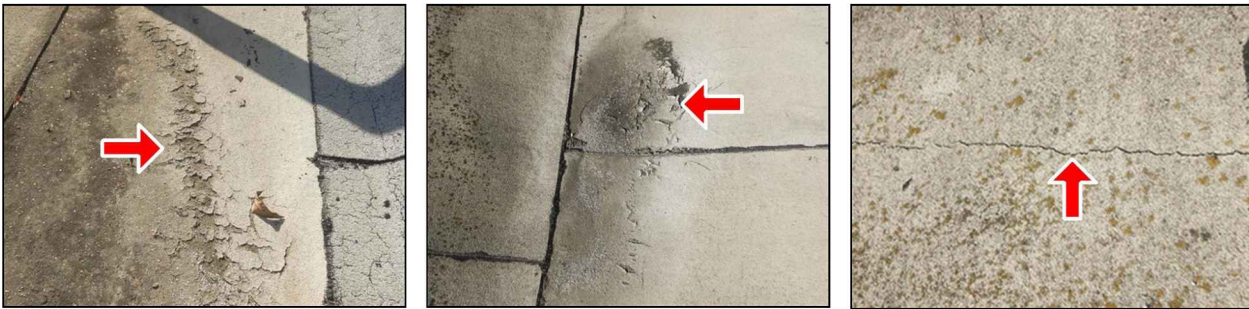
The cap sheet roofing was generally worn from exposure and was nearing the end of its expected service life. Even with routine maintenance, the need for replacement should be expected within the next few years and we recommend budgeting for this expense.

Worn roofing

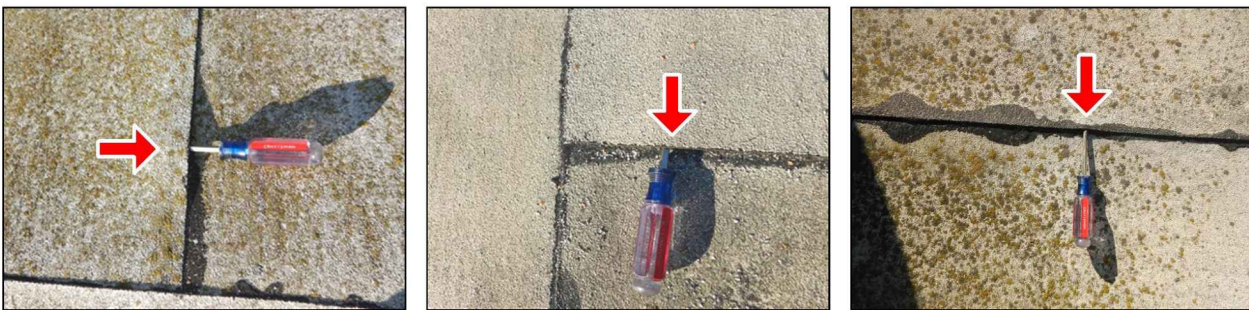
The seams in the cap sheet roofing were not properly sealed in several areas, which can allow water entry. We recommend review and repairs as necessary by a licensed roofing contractor.

Unsealed seams

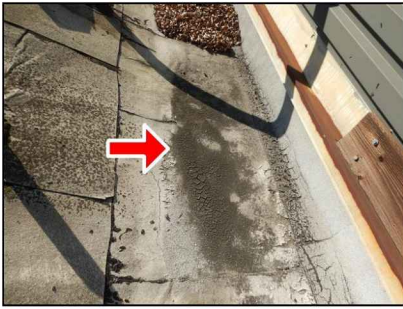
Ponding (or evidence of ponding) was observed on the roof. Ponding that clears up in 48 to 72 hours is usually considered normal and acceptable. Regular maintenance of ponding areas is important to keep the roofing in good condition. As is keeping all roof drainage features clear and flowing freely. When the roof is replaced, modifications to the roof deck should be made to ensure positive drainage.

Evidence of ponding

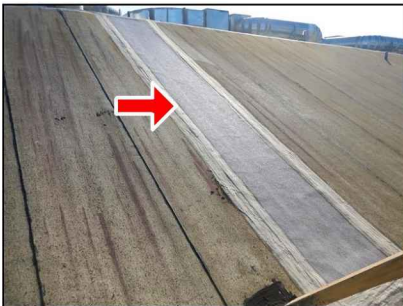
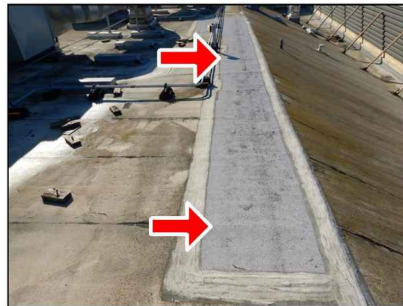
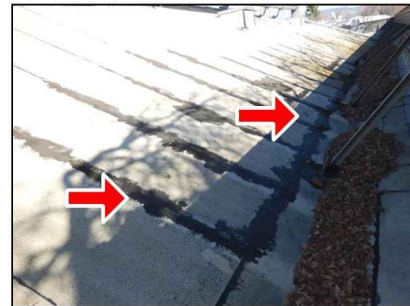
The roofing materials were patched in several areas. We recommend consulting with the property manager to learn more about these repairs and their significance. The need for ongoing maintenance should be anticipated.

Roof patches

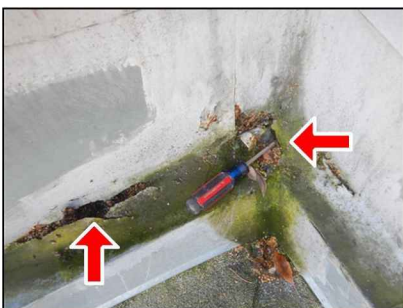
Some of the roof flashings were rusted. Significantly rusted flashings should be replaced while painting may be appropriate for the flashings in better condition. We recommend review and repairs as necessary by a licensed roofing contractor.

Rusted flashing

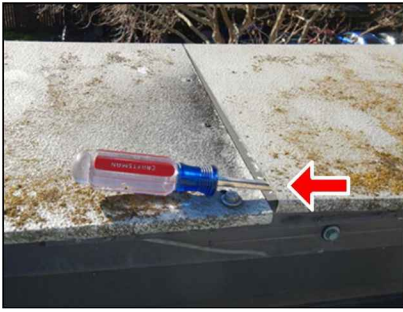
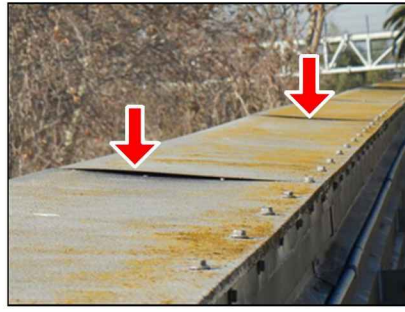
Separations were observed at the joints in the parapet cap flashings at the rear. These joints are very vulnerable to expansion and contraction, deterioration of the sealant, and water entry. We recommend review and repairs as necessary by a licensed roofing contractor.

Open cap flashing joints

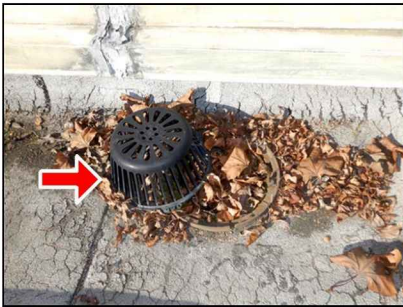
A strainer screen, intended to prevent debris from entering the roof drains, was loose at the left side. We recommend all drains be cleaned and strainers installed to prevent clogs.

Loose strainer

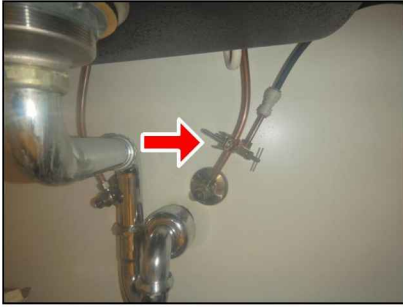
A saddle valve was installed on the water distribution piping in room N109 (Biology). Such fittings puncture the piping and rely on a washer to prevent leaks. Over time the washer will degrade, and we recommend replacement with appropriate fitting(s) by a licensed plumbing contractor.

Saddle valve

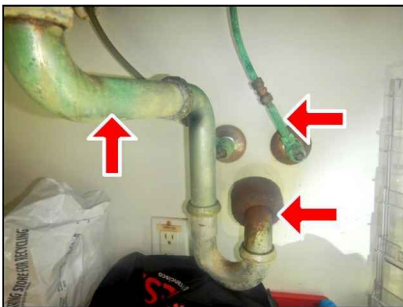
There was surface corrosion on the water supply piping below the sink in room N142 (Biology). No leaks were observed but may develop over time and for this reason we recommend periodic monitoring. As a precaution, all deteriorated, corroded or damaged supply pipe could be replaced by a licensed plumbing contractor.

Surface corrosion below sink

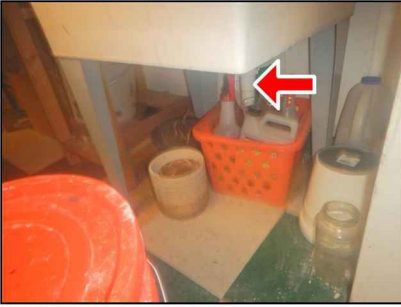
A utility sink in room N34 was missing a leg, which could cause instability. We recommend repair by a licensed plumbing contractor.

Missing utility sink leg

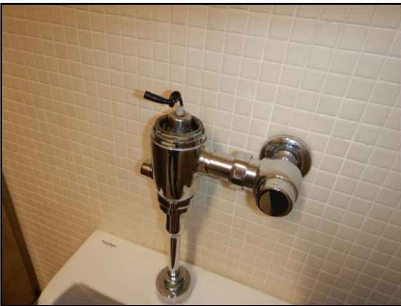
The flush valve sensor for the urinal in bathroom S223 was missing, and we recommend reinstallation by a licensed plumbing contractor.

Missing sensor

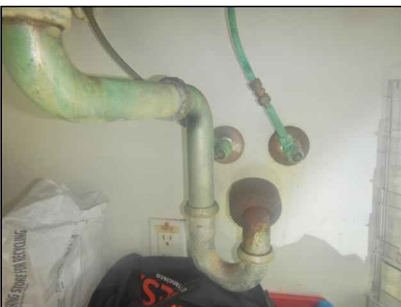
Minor corrosion was observed on several drain traps and adjacent piping. The piping should be checked periodically for signs of leakage and repaired or replaced when necessary.

Corroded piping

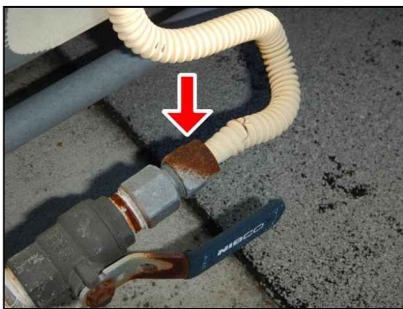
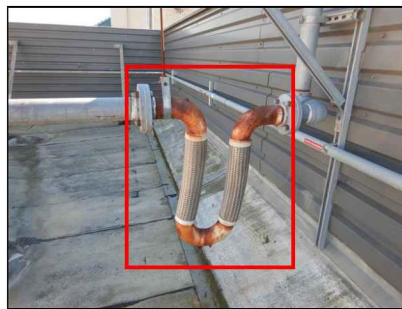
! We observed corrosion on the gas piping at the roof. Over time, this corrosion can lead to gas leaks and as a precaution, we recommend replacement of the gas piping by a licensed plumbing contractor.

Corroded gas lines

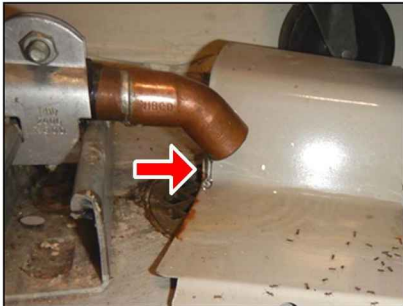
! The Room S1444 water heater relief valve was dripping, indicating a problem with the valve, the water heater, or the plumbing system. We recommend further evaluation and repairs as necessary by a licensed plumbing contractor.

Dripping TPRV

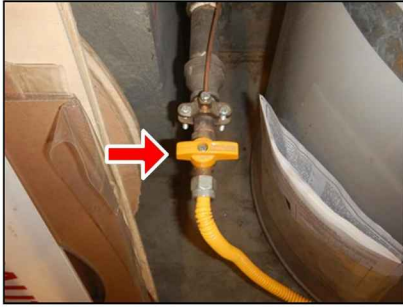
! The gas valve for the Room N111 water heater was turned off at the time of the inspection. The operations manager should be consulted as to the reason for why the valve was turned off. Operation of gas valves is beyond the scope of this inspection, and we recommend further evaluation and testing of the unit by a licensed HVAC or plumbing contractor.

Gas valve closed

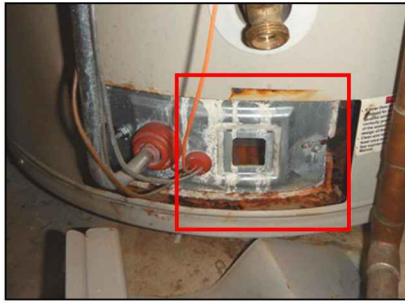
The S116 water heater was corroded at the base of the visible portions of the jacket, which is often is a symptom of impending failure. We recommend monitoring the tank for leakage and budgeting for its replacement when appropriate.

Corrosion at base

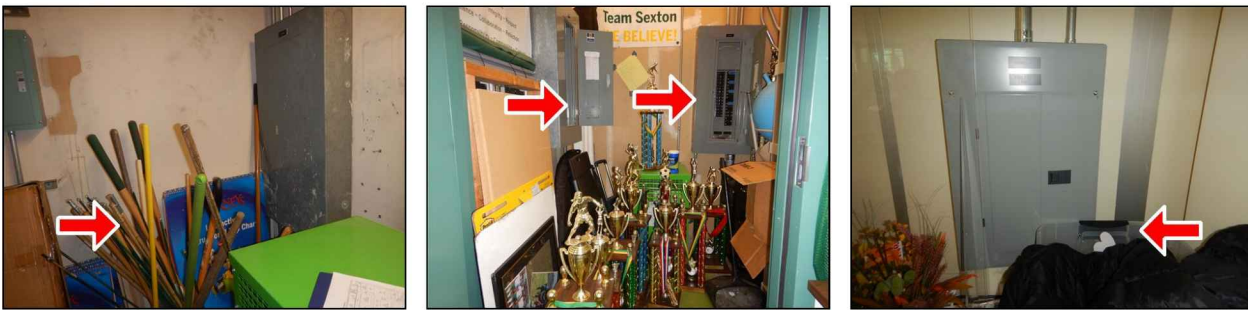
Stored items restricted clearances in front of several subpanels and blocked convenient and safe access. To ensure safety, most jurisdictions require at least 36 inches of clear, level space in front of a panel for an area that is 30 inches in width, extending from the floor or ground upward. We recommend moving these items to enable clear working space.

Blocked subpanels

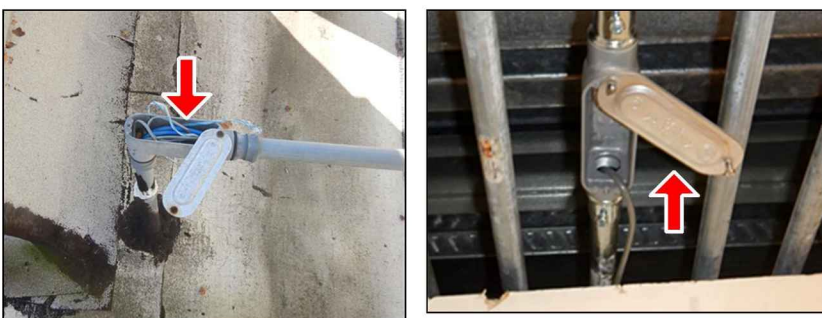
Pull boxes for metal conduit were open in room S134 and at the left side of the roof, leaving wiring exposed to damage. This can energize the conduit, creating a shock hazard. To eliminate this safety hazard we recommend review and repairs as necessary by a licensed electrical contractor.

Open pull boxes

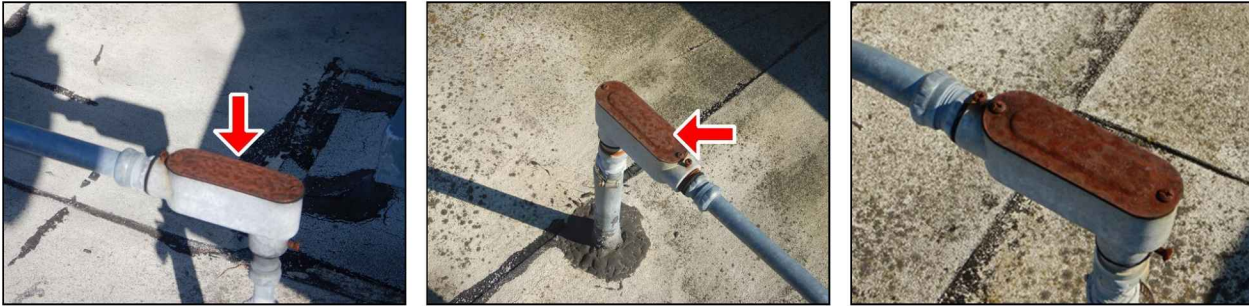
Sections of the metal conduit were corroded or deteriorated at the roof. The damaged conduit should be repaired or replaced to reduce any potential hazards. We recommend review and repairs as necessary by a licensed electrical contractor.

Corroded conduit

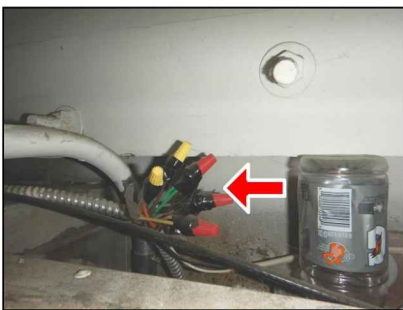
Substandard electrical splices were observed in a few areas. "Running" splices indicate work by unprofessional or untrained workers and current standards require splices to be made inside junction boxes. We recommend review and repairs as necessary by a licensed electrical contractor.

Running splices

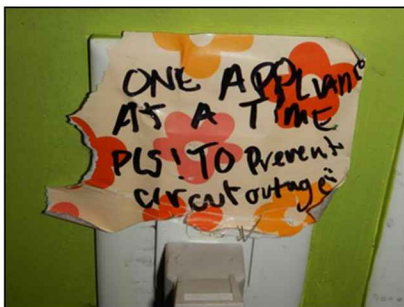
⚠ A sign on a receptacle in Room S202 indicated that this circuit was overloaded and prone to tripping. We recommend further evaluation and repairs as necessary by a licensed electrical contractor.

Sign indicating overloading

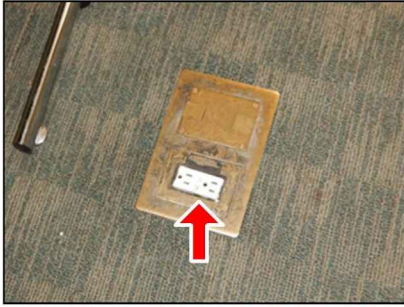
The outlet used in the floor of the in room N104 was not appropriate for use in floors. Floor receptacles require special boxes and covers. We recommend review and repairs as necessary by a licensed electrical contractor.

Improper floor receptacle

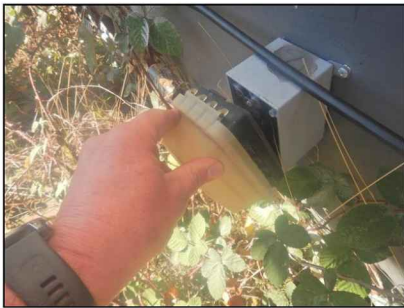
The cover for a receptacle was loose at the exterior left side. We recommend immediate replacement to reduce the risk of electrical shorts and hazardous shocks.

Loose cover

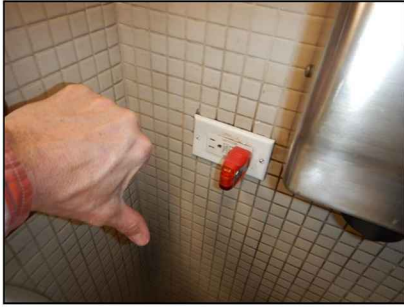
- ⚠ Ground Fault Circuit Interrupter (GFCI) protection was installed for some, but not all, of the receptacles where this type of protection is presently required. GFCI protection is a modern safety feature designed to help prevent shock, particularly in wet locations. The protection is inexpensive and can provide a substantially increased margin of safety. We recommend upgrading of unprotected receptacles in areas where GFCI protection is presently required.
- ⚠ Several GFCI receptacles in the bathrooms would not trip when the test buttons were pushed, creating shock hazards. We recommend a licensed electrical contractor replace all faulty GFCI receptacles to restore the protection afforded by this important safety device.

Defective GFCI receptacle

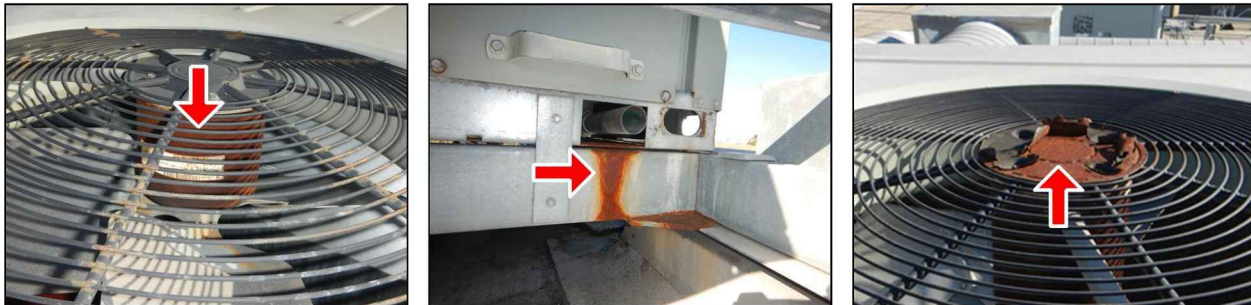
Rust & corrosion was observed on the package units, indicating that they are near the end of their expected services lives. The systems were 17 year old, and have a typical lifespan of 20 years.

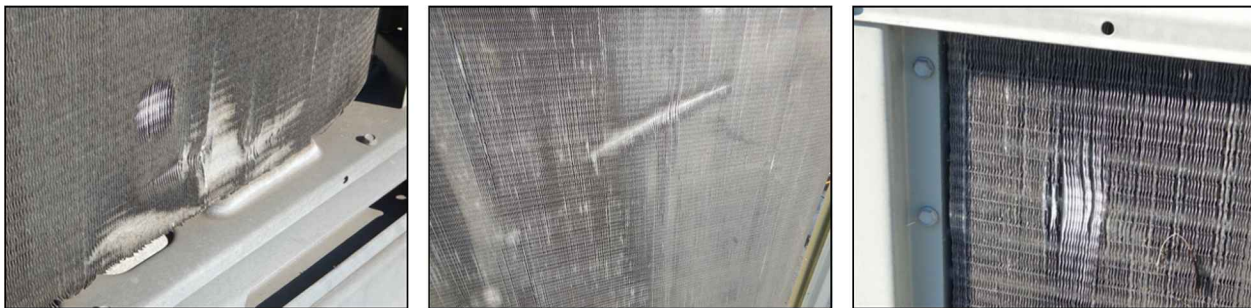
Some of the metal fins on the condensing units were damaged. Damaged fins can reduce the efficiency, and as a part of routine maintenance, we recommend the damage fins be straightened to improve performance.

Damaged fins

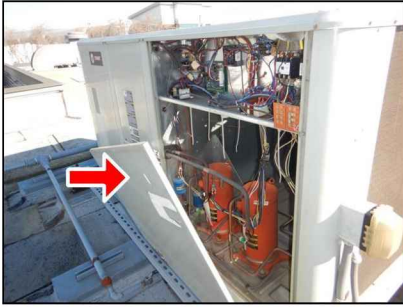
One of the access panels had fallen off HVAC #16, and we recommend reattachment by a licensed HVAC contractor.

Loose panel

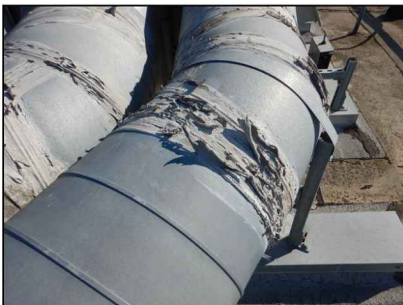
The mastic or sealant used to seal some of the rooftop ductwork was deteriorated, cracked, or missing. We recommend review and repairs as necessary by a licensed HVAC contractor. The need for ongoing maintenance should be anticipated.

Deteriorated mastic

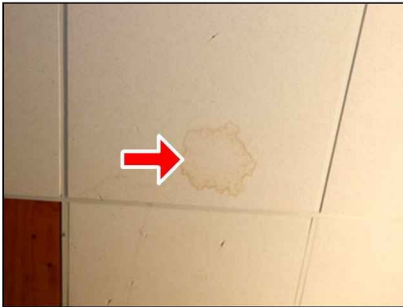
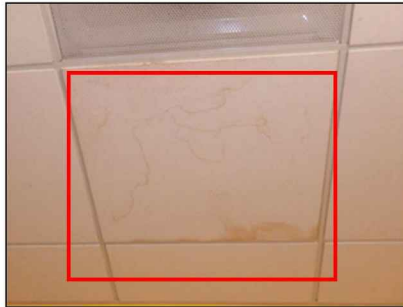
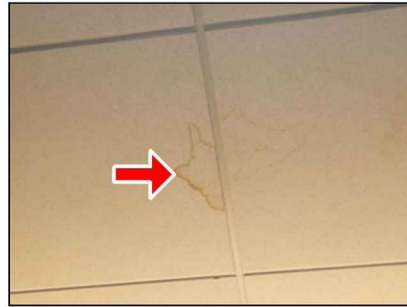
The drop ceilings were stained in several areas. We recommend further evaluation and repairs as necessary by a licensed contractor.

Stained drop ceiling

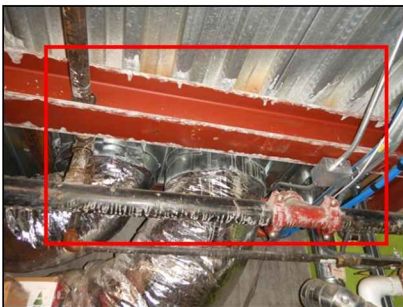
Ceiling stains or damage, symptomatic of water leaks, were observed in room S116. We recommend consultation with the property manager for more information. If proof of remedial action is not available, we recommend further evaluation and repairs as necessary by a licensed contractor.

Ceiling stains

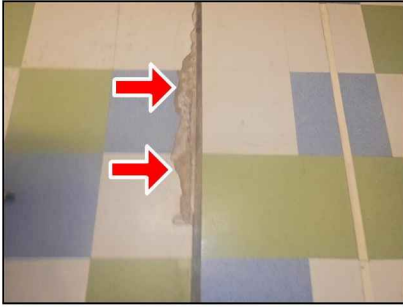
Damaged flooring
