HVAC Assessment Report

California Schools Healthy Air, Plumbing, and Efficiency Ventilation Program
(CalShape - formerly AB 841)

Lighthouse Community School

Lighthouse Community School – 444 Hegenberger rd. Oakland CA 94621

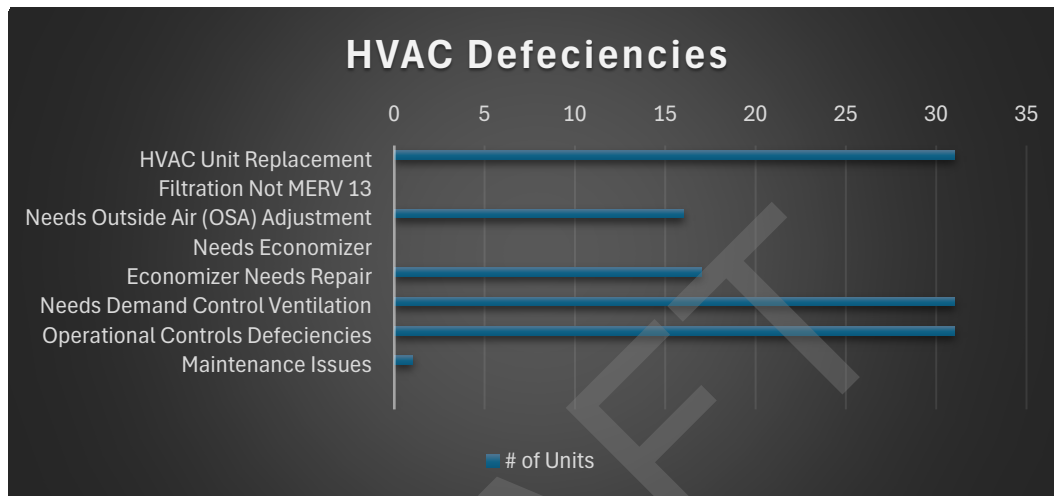
The graph and table below summarize the key findings from the HVAC assessment conducted at Lighthouse Community School. Detailed information for each individual HVAC unit is provided in the appendix, which includes summary tables and data sheets. An overview of the common types of HVAC equipment found at the school is presented in Section 2.4, while Section 2.5 outlines typical deficiencies frequently observed across the campus.

Lighthouse Community School has 31 HVAC units, most of which are around 16 years old and have exceeded their expected useful life. The district has done an excellent job maintaining the equipment, with few reported issues and only a small number of economizers in need of repair. However, due to the age of the systems, they are inherently less efficient, more susceptible to failure, and increasingly expensive to maintain. Rather than continuing to invest in outdated units, a replacement strategy is recommended—one that incorporates modern features such as Demand Control Ventilation (DCV), which adjusts airflow based on occupancy to reduce energy use and improve indoor air quality by lowering CO₂ levels in classrooms and shared areas. All existing units support MERV 13 filters, and using 2-inch thick versions is advised for optimal performance. Upgrading to new systems with these advanced capabilities will enhance comfort, efficiency, and sustainability throughout the school.

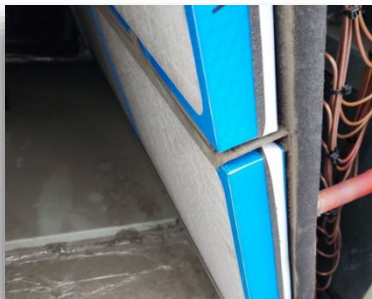
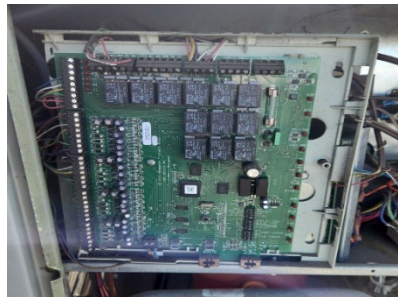
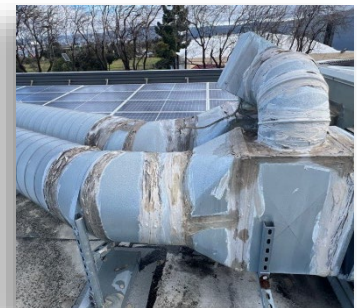
MEV 16 Filters, Zone control board, Ducting with Bypass Damper

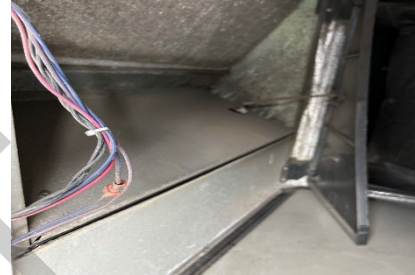
Economizer Component Degradation in Aged Rooftop Units

Mechanical rooftop units nearing or past their expected service life often experience high failure rates in economizer components. Common issues include corroded dampers, worn linkages, and failed actuators—primarily due to age, wear, and environmental exposure.

While many of these units require economizer repairs, the advanced age of the equipment raises concerns about cost-effectiveness. Repairs may offer limited value as other components are also likely to fail soon.

Recommendation: Evaluate the cost-benefit carefully. In many cases, replacing the entire unit may be more prudent than investing in short-term fixes. If the equipment is less than 15 years old and in good functioning shape repairing or adding economizers is recommended.
