Inspection Report

Prepared For:
**Rich Harrison, Lighthouse
Community Public Schools**

Report Number:
T0107

**444 Hegenberger Rd
Oakland, CA**

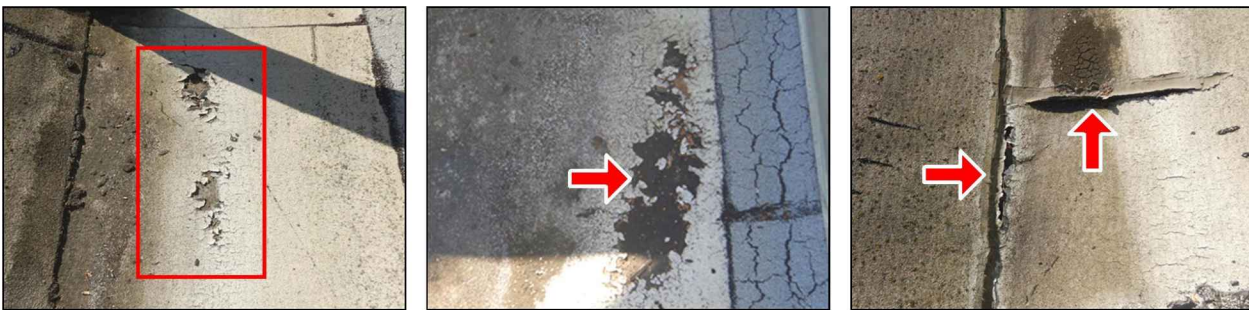
Worn roofing

The seams in the cap sheet roofing were not properly sealed in several areas, which can allow water entry. We recommend review and repairs as necessary by a licensed roofing contractor.

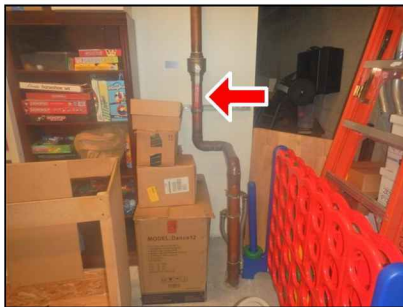
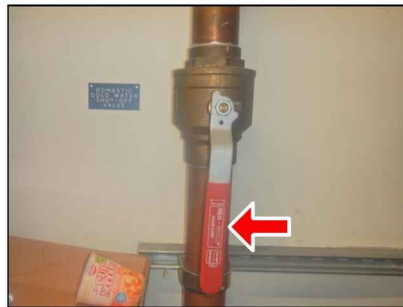
Main water disconnect

The main water supply shut-off valve was located, but testing the operation of this valve is not within the scope of this inspection. Operation of the valve from time to time will keep it functional and maximize its useful life.

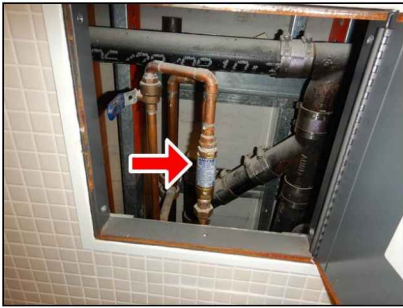
Trap primer

Floor drain trap primers were observed in some of the bathrooms. Trap primers are used to keep water in floor drain traps, so they don't dry out and let sewer gases enter the building. If sewer odors are ever detected in these areas, it is likely that the trap primer has failed and will need to be replaced.

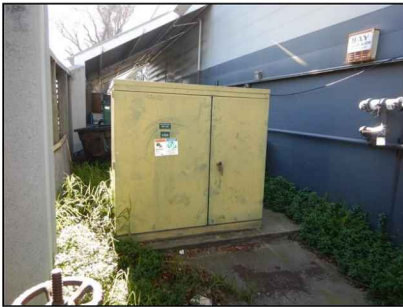
Transformer

A pad mounted utility transformer was located at the left side. This transformer was the property of the local utility. If any adverse conditions are observed regarding the transformer, the local utility should be contacted.

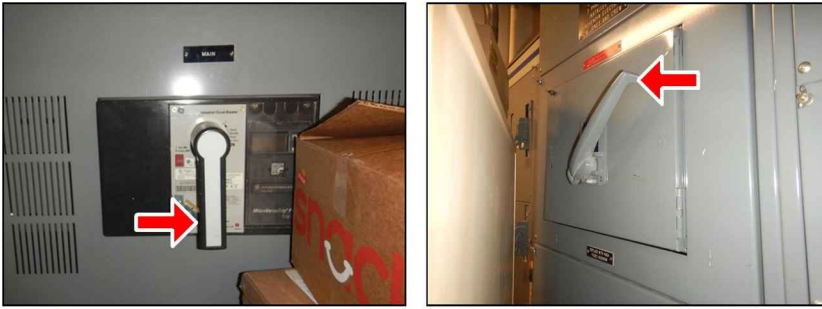
Main electrical disconnects

The function of the main disconnect was provided by levers on the main panels. The levers appeared to be in acceptable condition, but were not tested for operation.

The short circuit rating of the equipment was 50,000 amps. We recommend contacting the electric utility to determine if the short circuit rating of the main service equipment is adequate for the available fault current. Equipment that is not properly rated may prevent protective devices from tripping in some circumstances, creating a potential fire, explosion, and shock hazard.

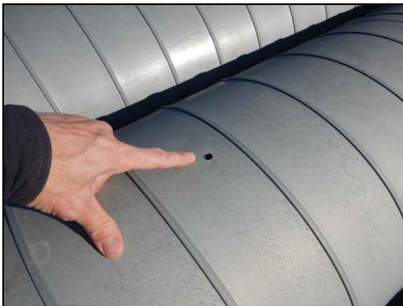
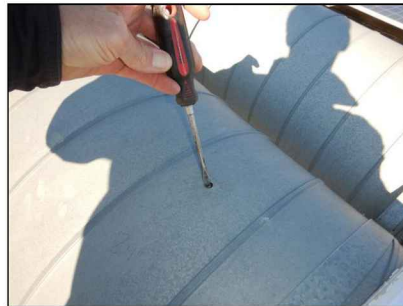
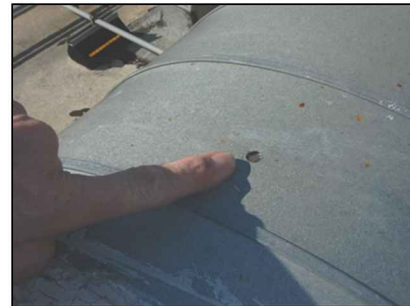
Several ducts has small holes, which can waste energy and lead to increased utility bills. We recommend sealing of holes in the ductwork by a licensed HVAC contractor.

The mastic or sealant used to seal some of the rooftop ductwork was deteriorated, cracked, or missing. We recommend review and repairs as necessary by a licensed HVAC contractor. The need for ongoing maintenance should be anticipated.

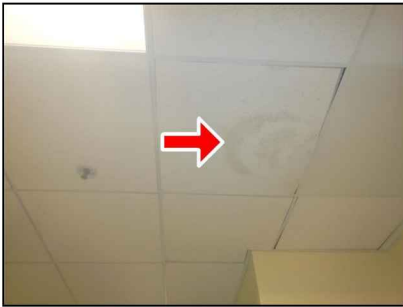
Stained drop ceiling

Ceiling stains or damage, symptomatic of water leaks, were observed in room S116. We recommend consultation with the property manager for more information. If proof of remedial action is not available, we recommend further evaluation and repairs as necessary by a licensed contractor.
